CONSTRUCTION GENERAL PERMIT SITE INSPECTION - LEVEL 1 (FOCUSED)

Project Name: Hollymead 230 KV Utility Line

Permit Number (if applicable): VAR100076

Construction General Permit Site Inspection Photo Log

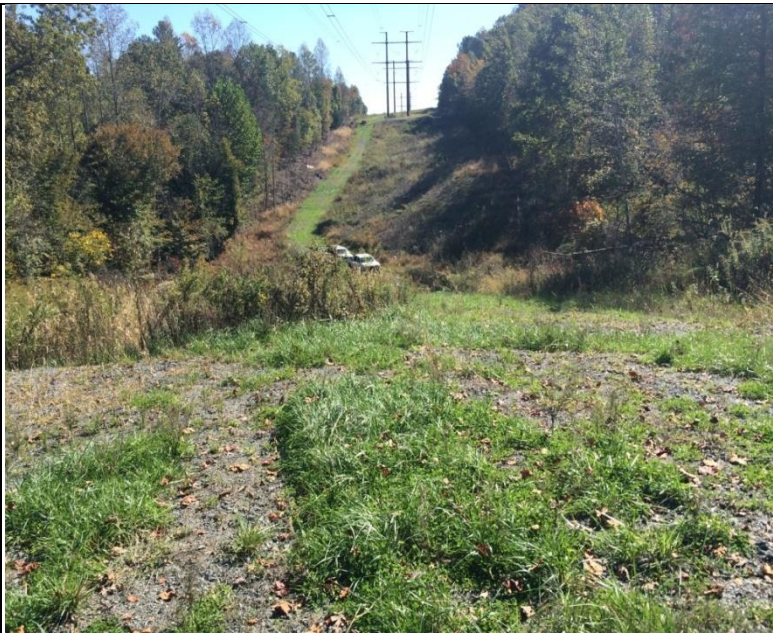
There is a small section of silt fence that should be removed on the left above the vehicles. (photo 1)

Checklist #	Regulatory Citation/Legal requirement ¹	Occurrence	Observation/Legal Requirement/Recommended Corrective Action
7	9VAC25-870-54.B	Initial	<p>Observation: There were a few sections of temporary silt fence that have not been removed. (pictures 1)</p> <p>Recommended Corrective Action: Remove temporary measures in accordance with the 2011 Dominion Specification TE VEP 8000 – General Erosion and Sedimentation Control Specifications for the Construction and Maintenance of Electric Transmission Lines.</p>
8	9VAC25-870-54.C 9VAC25-840-40(18)	Repeat	<p>Observation: Temporary gravel access roads, and gravel pads were left in place. (pictures 2-6)</p> <p>Recommended Corrective Action: Stormwater quality and quantity may be affected due to the temporary impervious areas being left in place without adequate controls to address the water quality and water quantity requirements of the Construction General Permit. In accordance with 2011 Dominion Specification TE VEP 8000 – General Erosion and Sedimentation Control Specifications for the Construction and Maintenance of Electric Transmission Lines, such roads and pads are to be removed at the conclusion of the project</p>

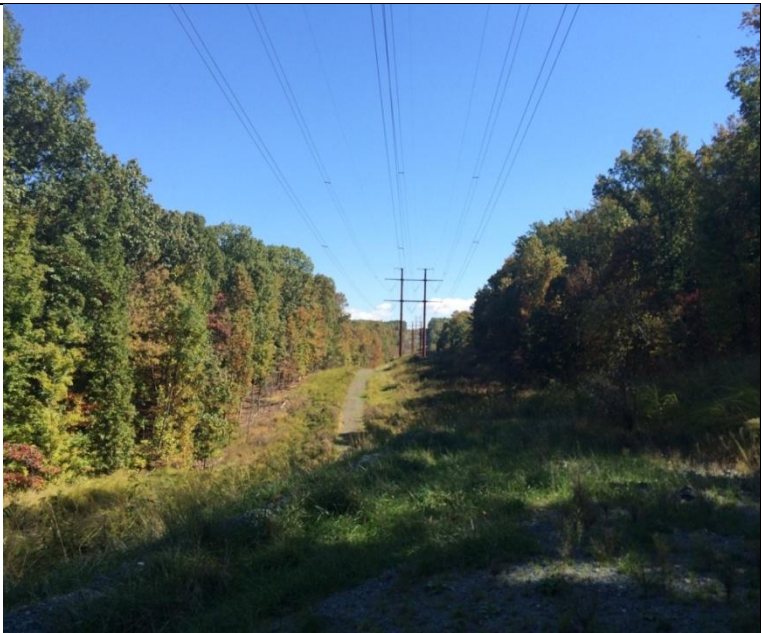
Temporary gravel road that was left in place. (photo 2)

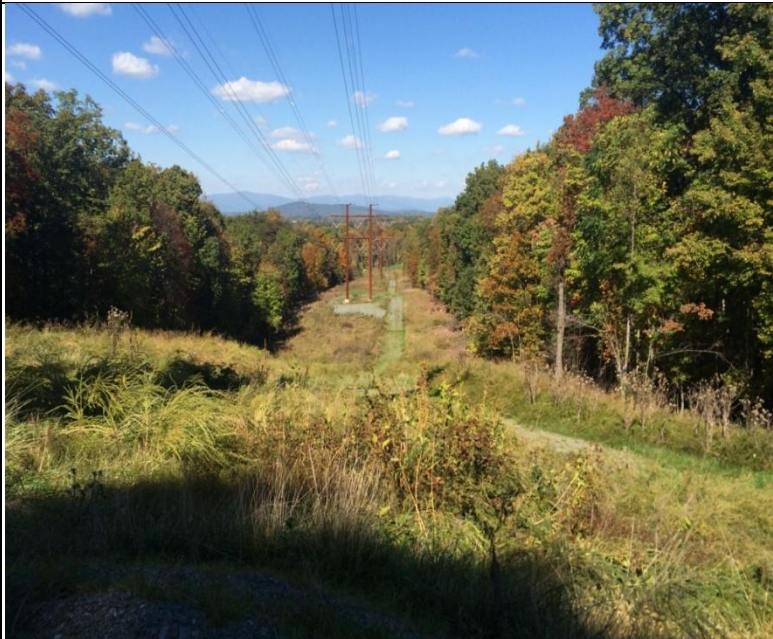
Temporary gravel road that was left in place. (photo 3)

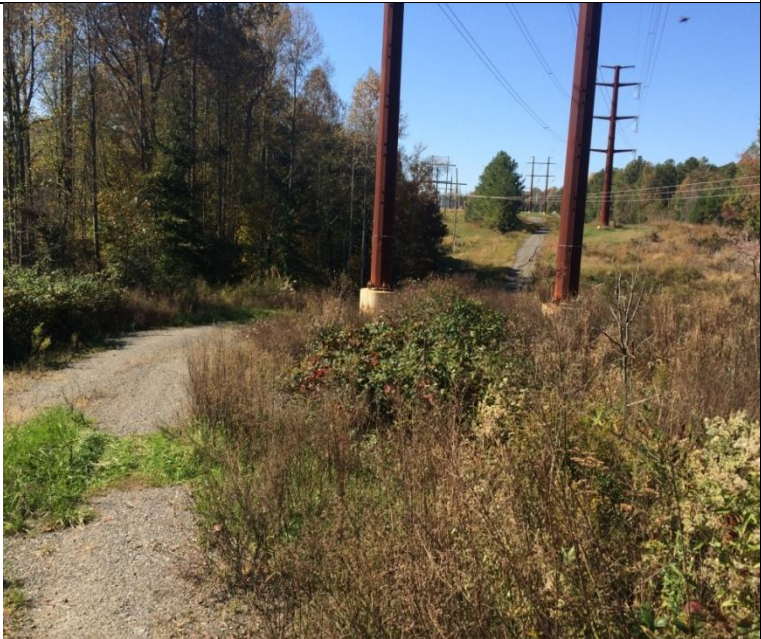
Temporary gravel road that was left in place. (photo 4)

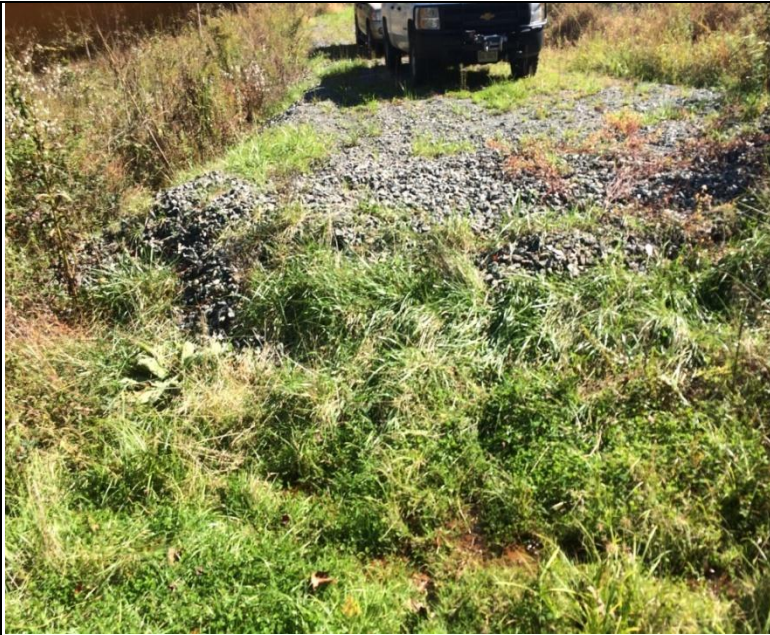
Temporary gravel road that was left in place. (photo 5)

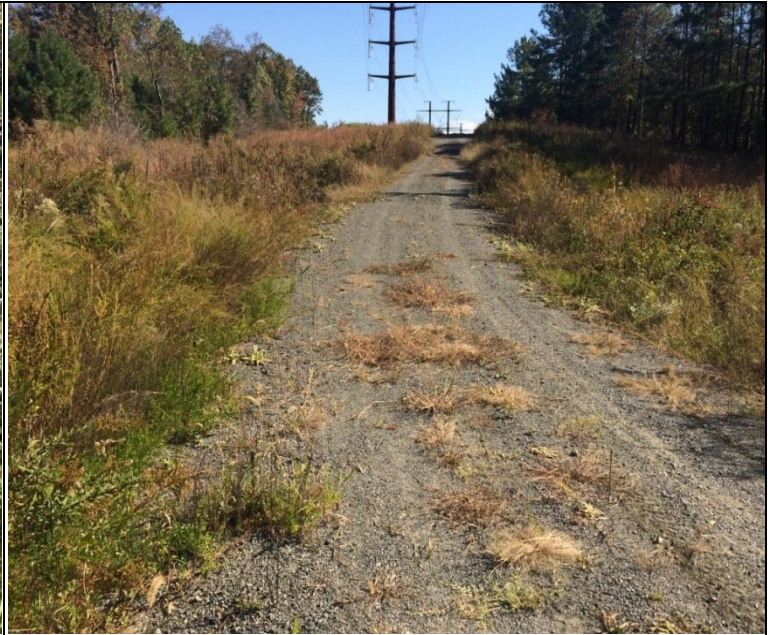
Temporary gravel road that was left in place. (photo 6)

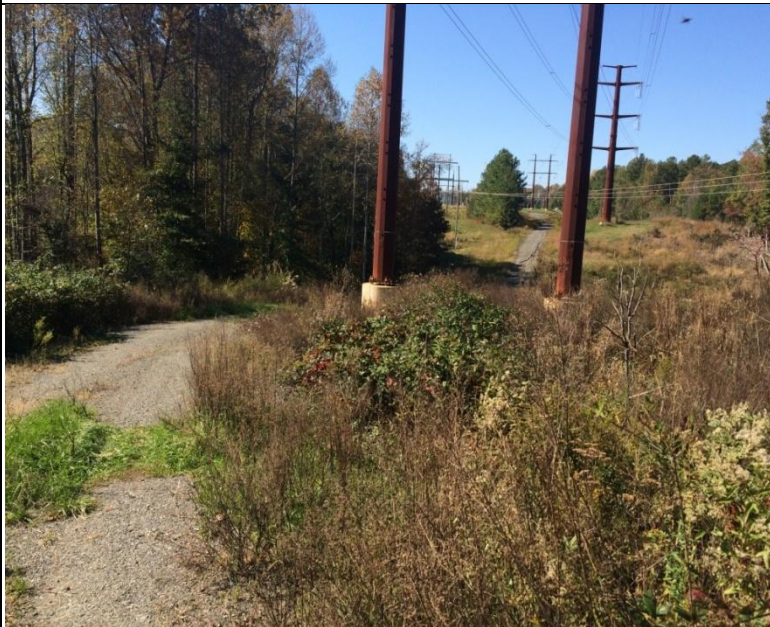
11		Initial	<p>Observation: There was active erosion and sedimentation at a few culvert outlets, and along sections of the gravel access road. (pictures 7-9)</p> <p>Recommended Corrective Action: Areas should be stabilized in accordance with the requirements of the annual standards and specifications that were in place at the time of construction. (2011)</p>

Gully erosion on temporary access road in the background between the poles. (photo 7)

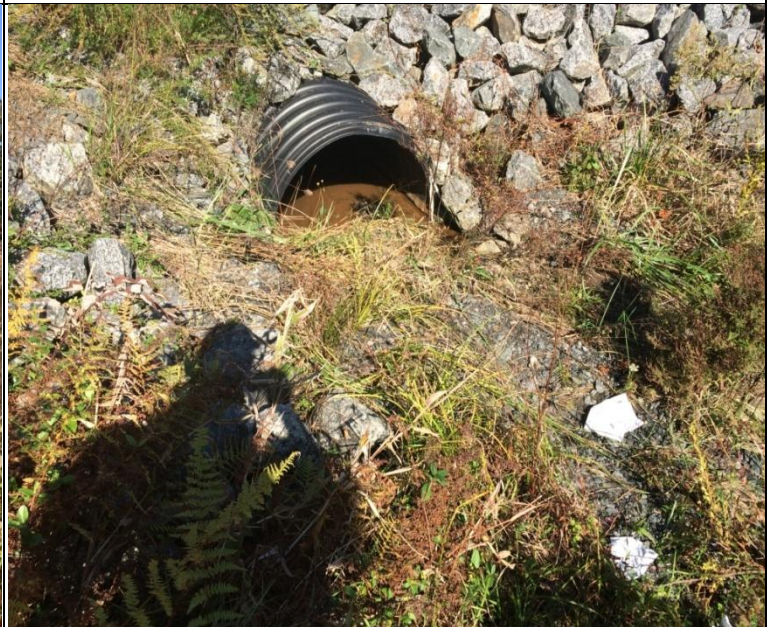
Evidence of the temporary access road eroding at an outfall between the poles shown in photo 7. (photo 8)

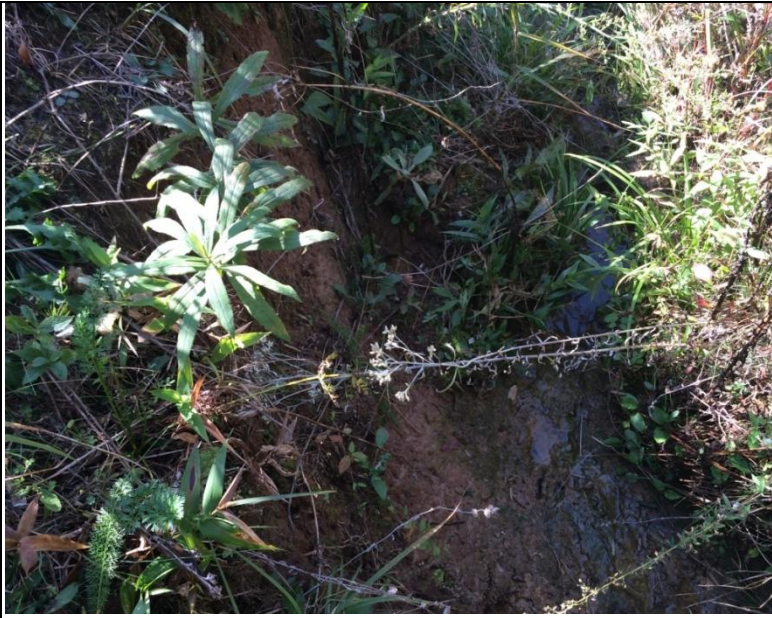
Erosion at the outfall of a culvert that goes under the temporary access road. (photo 9)
